# **INDOOR AIR QUALITY ASSESSMENT**

**Bennett School  
145 Pleasant Street  
Leominster, MA 01453**

Prepared by:  
Massachusetts Department of Public Health  
Center for Environmental Health  
Emergency Response Indoor Air Quality Program  
September 2005

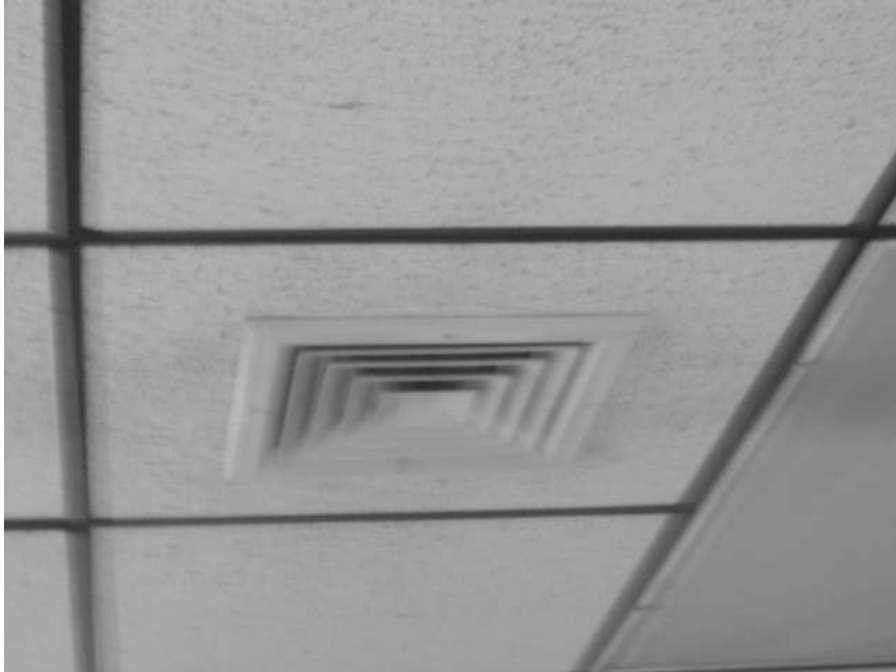
**Picture 2**

Mechanical ventilation is provided to modular classrooms by rooftop air-handling units (AHUs). Fresh air is supplied to the classroom by ceiling mounted diffusers (Picture 2), and air is returned to the AHUs via ceiling mounted exhaust vents (Picture 3). Thermostats control each heating, ventilating and air conditioning (HVAC) system and have fan settings of “on” and “automatic”. Thermostats were set to the “automatic” setting (Picture 4) in both of the modular rooms during the assessment. The “automatic” fan setting on the thermostat activates the HVAC system at a preset temperature. Once the preset temperature is reached, the HVAC system is deactivated. Therefore, no mechanical ventilation is provided until the thermostat re-activates the system. All areas in the modular building had elevated carbon dioxide levels, indicating inadequate air exchange in these areas. At the time of the assessment, the mechanical ventilation had cycled off.

**Ceiling-mounted supply diffuser for modular classroom**

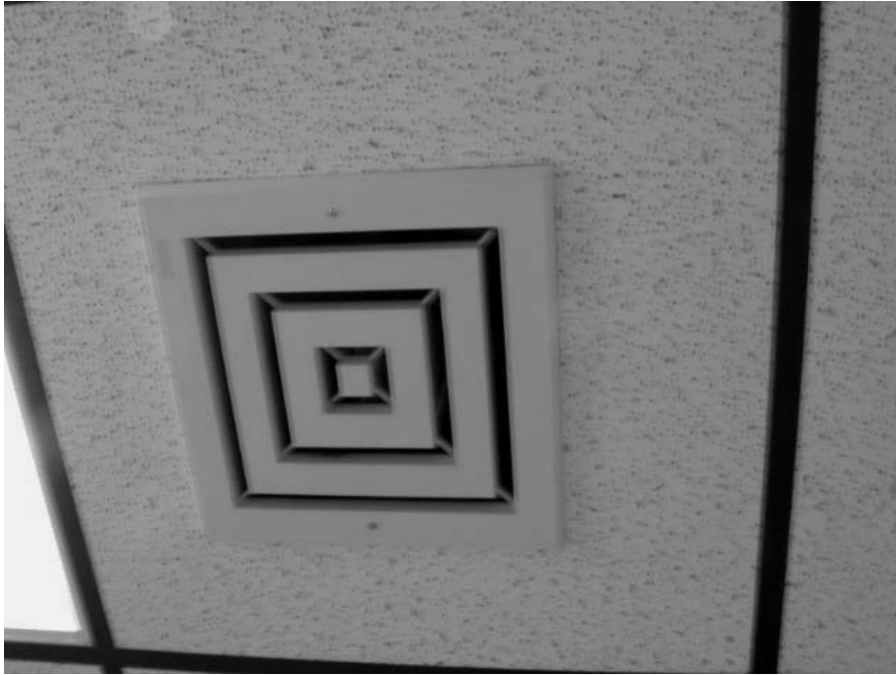
**Picture 3**

**Ceiling-mounted return for modular classroom**

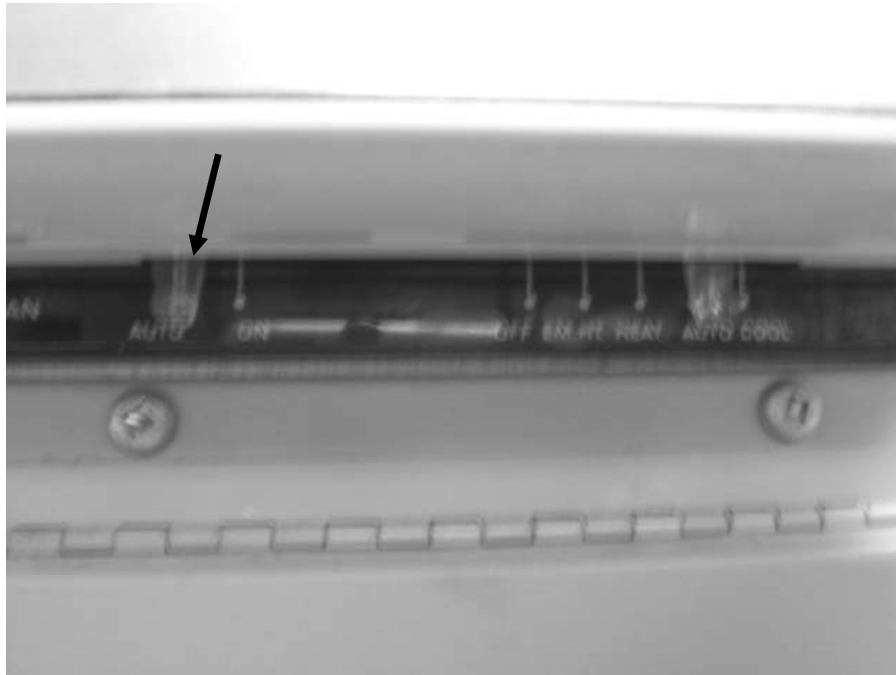
**Picture 4**

the modular areas, temperature ranged from 71 ° F to 76 ° F, or within the MDPH recommended temperature guidelines. In many cases concerning indoor air quality, fluctuations of temperature in occupied spaces are typically experienced, even in a building with an adequate fresh air supply. It is often difficult to control temperature and maintain comfort without operating the ventilation equipment as designed. The original fresh air supply system to classrooms in the main building acted to pressurize each classroom by the flow of rising air from supply ducts. This pressurization is now absent due to the abandonment of this system. For the classrooms in the modular building, thermostats were set to automatic, thereby limiting the amount of fresh air supplied to classrooms.

**AHU thermostat fan set to 'auto'**

3. Set the thermostats in the modular classrooms to the fan “on” position to operate the ventilation system continuously during occupancy.
4. For buildings in New England, periods of low relative humidity during the winter are often unavoidable. Therefore, scrupulous cleaning practices should be adopted to minimize common indoor air contaminants whose irritant effects can be enhanced when the relative humidity is low. To control for dusts, a high efficiency particulate arrestance (HEPA) filter equipped vacuum cleaner in conjunction with wet wiping of all surfaces is recommended. Avoid the use of feather dusters. Drinking water during the day can help ease some symptoms associated with a dry environment (throat and sinus irritations).

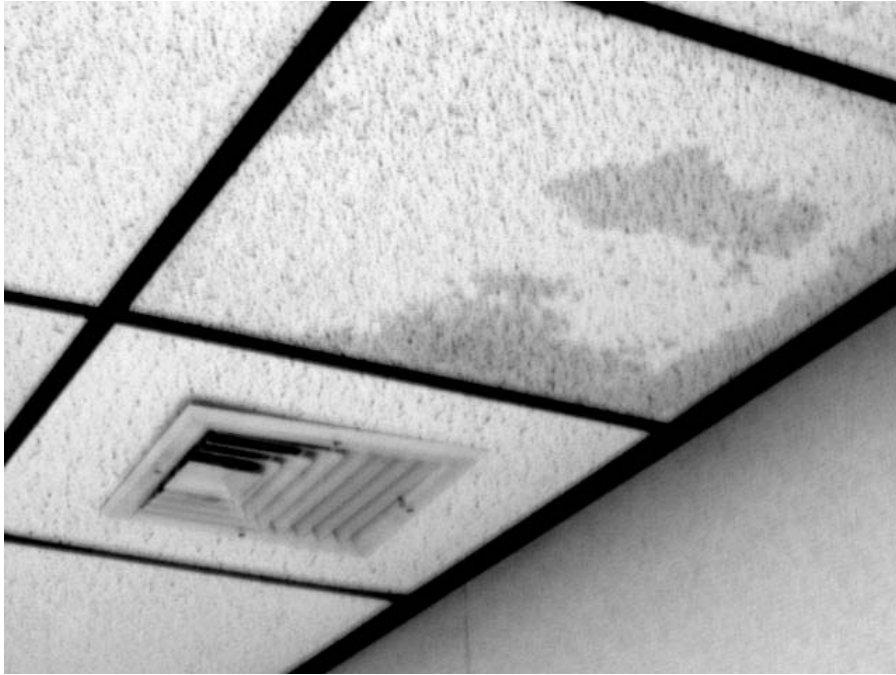
**Picture 5**

A few areas had water-stained ceiling tiles (Picture 5), which can indicate leaks from the roof or plumbing system. Water-damaged ceiling tiles can provide a source for mold and should be replaced after a water leak is discovered and repaired. Water-damaged ceiling and wall plaster were also observed throughout the school (Pictures 6 and 7). Although water-damaged ceiling plaster is not a source for mold growth, moistened dust trapped in spaces between the paint layers can become mold growth media.

**Water-stained ceiling tiles**

5. Ensure leaks are repaired, and replace water damaged ceiling tiles. Examine the area above and around these areas for mold growth. Disinfect areas of water leaks with an appropriate antimicrobial.

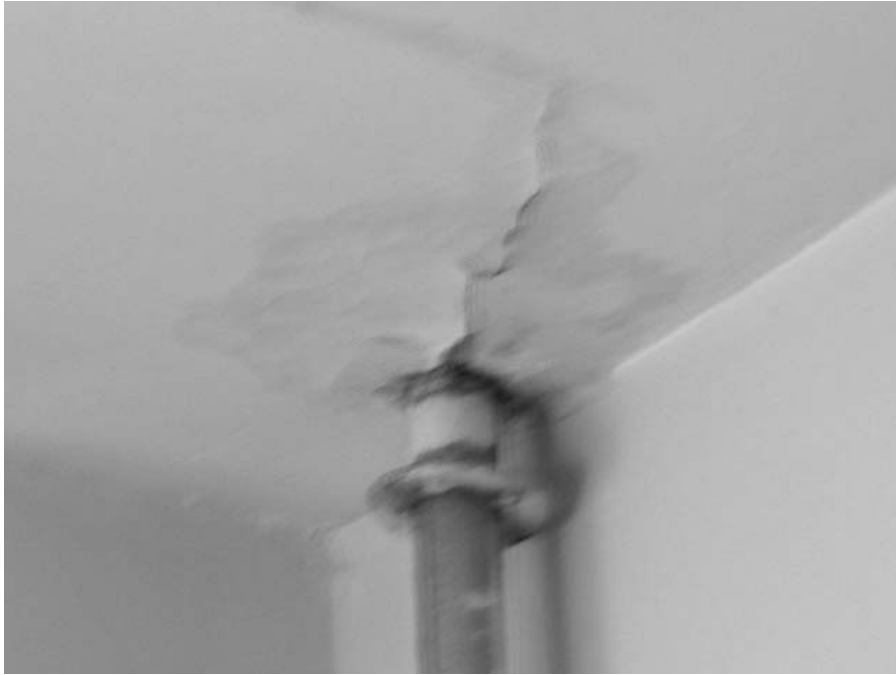
**Picture 6**

**Water-damaged ceiling plaster**

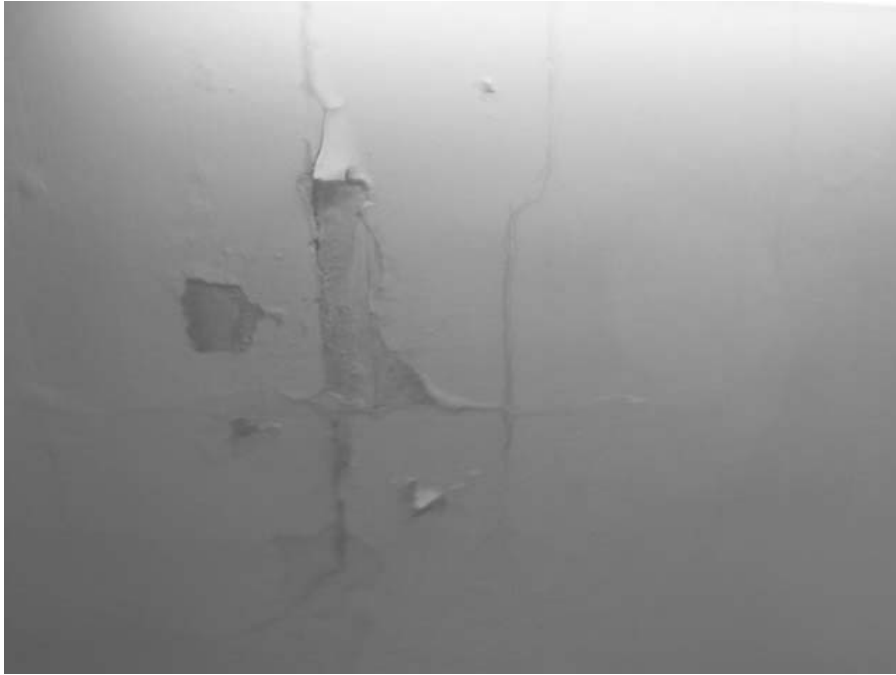
**Picture 7**

**Water-damaged wall plaster**

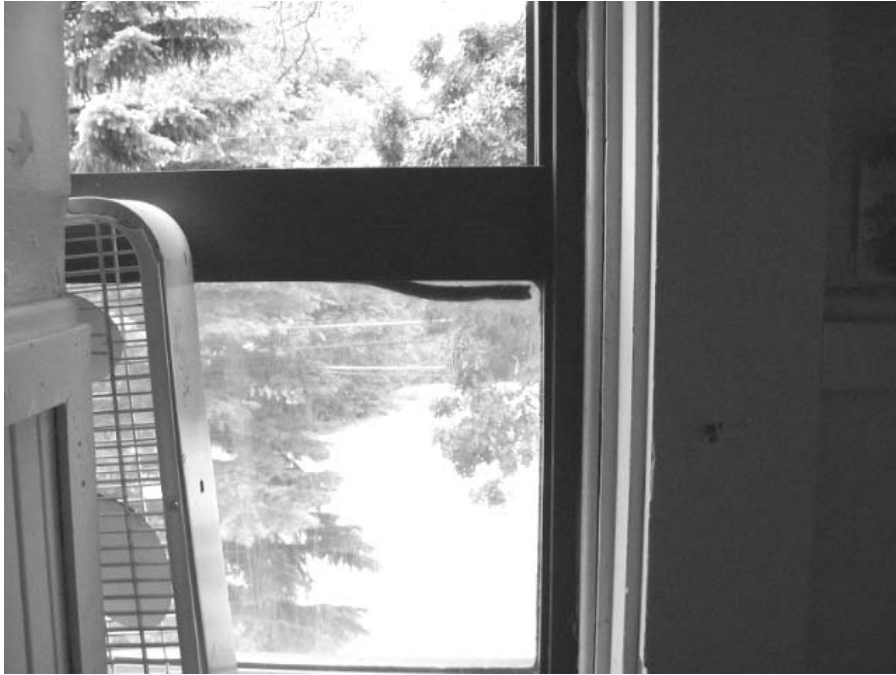
**Picture 8**

Other sources for water penetration to the building were observed. Breaches were noted in and around the building and its windows. A rubber gasket for a classroom window was also failing (Picture 8). These breaches can serve as points for water entry into the building. Continued freezing and thawing of water during cooler months will serve only to further damage the frame. In addition, breaches can serve as points of entry or shelter for pests. The side paneling to a window bay was damaged. Since the panel is no longer intact, water can penetrate the building interior.

**Damaged rubber gasket in window frame**

9. Continue to replace remaining windows on the capital repair list and as funds become available. In the interim, re-seal loose window frames to prevent drafts and water penetration.

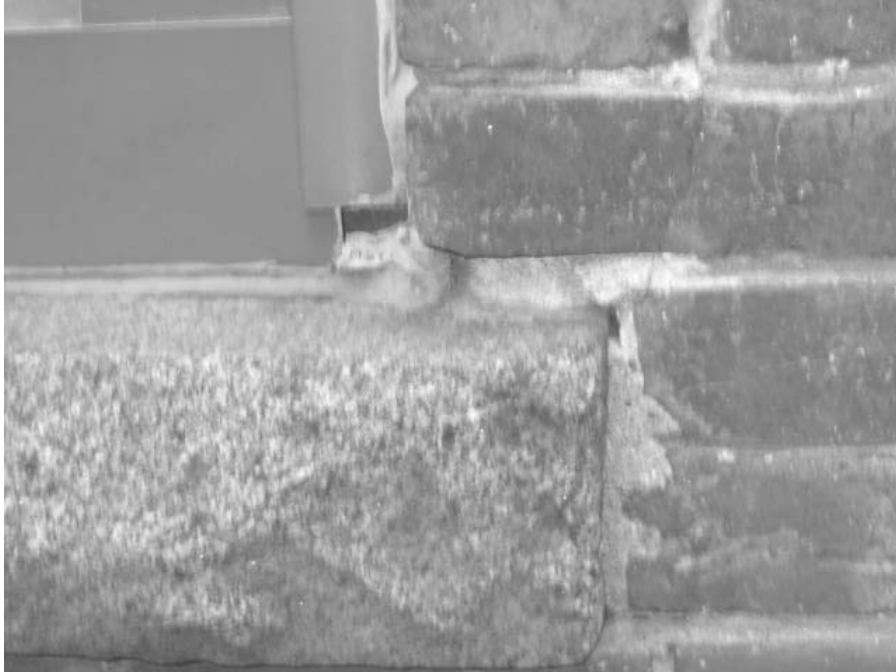
**Picture 10**

A number of breaches were seen around the building exterior (Pictures 9 and 10). Missing mortar around brickwork was noted in a number of areas. Damage to the modular classroom exterior wall was also observed (Picture 11). Holes, breaches, and seams are points through which water can penetrate the building, particularly under driving rain conditions. In addition, the gutter/downspout system was damaged/missing or improperly connected in some areas around the modular classrooms. Portions of the exterior wall were wet as a result of improperly connected downspouts (Picture 12). Excessive exposure of the building exterior to water can result in structural damage. Over time, these conditions can undermine the integrity of

**Breaches around window**

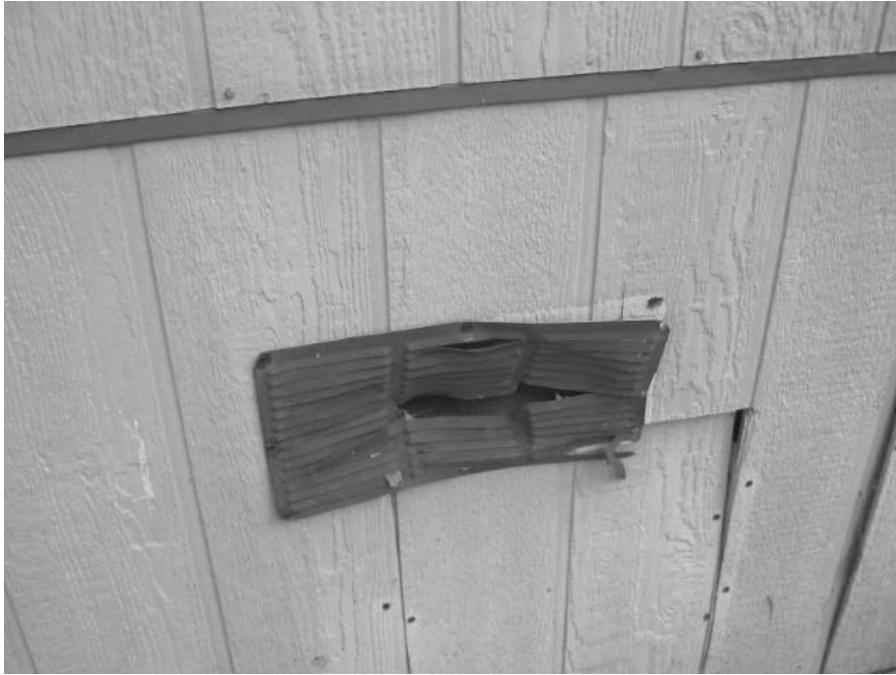
**Picture 11**

**Damaged exterior wall to modular classrooms**

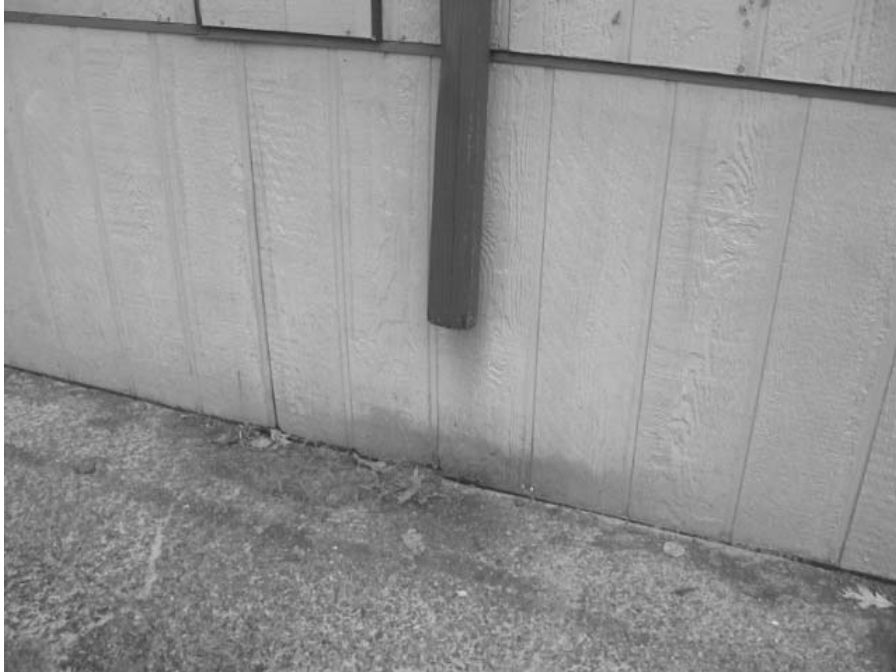
**Picture 12**

**Downspout with missing components, note water stains to exterior wall**

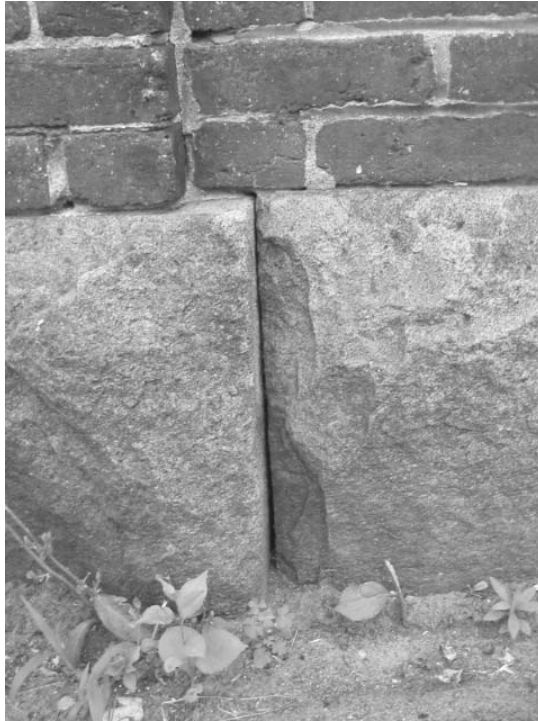
**Picture 13**

Lastly, plants were observed to be growing against the foundation walls between cracks and in subterranean pits (Pictures 13 and 14). The growth of roots against exterior walls can bring moisture in contact with the foundation. Plant roots can eventually penetrate, leading to cracks and/or fissures in the sublevel foundation.

**Plants growing against building**

6. Remove plants from the wall/tarmac junction around the perimeter of the building.
7. Contact a masonry firm or general contractor to repair missing/damaged mortar on exterior brick to prevent water penetration, drafts and pest entry.

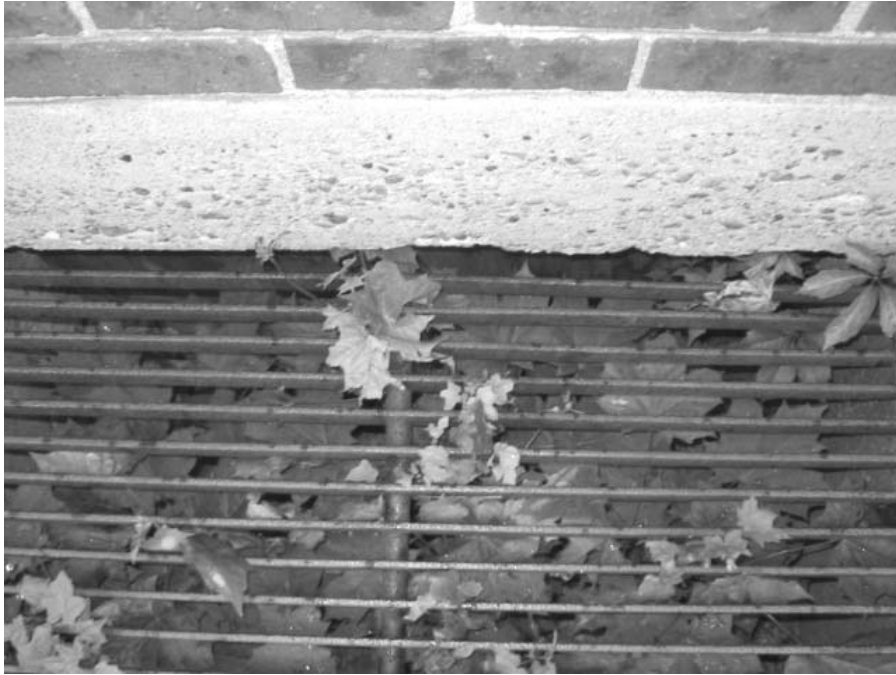
**Picture 14**

**Plants growing in subterranean pit**
